MULTIMATERIAL LAMINATION AS A MEANS OF RETARDING PENETRATION AND SPALLATION FAILURES IN PLATES

by John D. DiBattista and Donald H. Humes

Langley Research Center

NATIONAL AERONAUTICS AND SPACE ADMINISTRATION • WASHINGTON, D. C. • NOVEMBER 1972

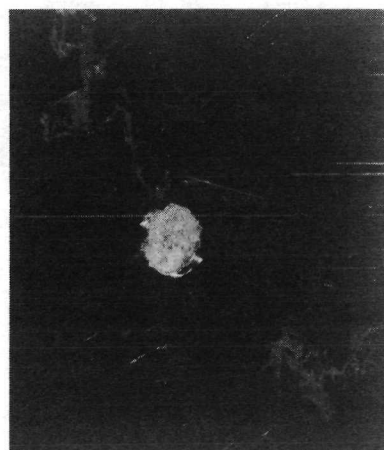
L-72-6571

(a) Front view of solid 2024-T3
aluminum main wall.

(b) Rear view of solid 2024-T3
aluminum main wall.

Figure 18.- Photographs of damage done to a solid main wall used in shot 28, table III.

A detailed examination of the solid aluminum main walls shown in figures 17 and 18 shows the brittle material response of the walls to the projectile-bumper debris cloud. It appears that an extremely short duration but intense compression wave was produced in the main wall by the impacting debris cloud. Reflection of a relaxation wave after the

intense compressional wave reached the main-wall rear surface helped induce a large velocity gradient and, therefore, a large displacement gradient normal to the main-wall surfaces over a large circular area in the plate. A large penny-shaped crack formed and a spallation failure occurred, leaving a roughened spall area shown in figures 17 and 18. Then, in shot 30 either stresses in the main-wall material between the spall region and upper pitted surface of the main wall propagated cracks from the roughened spall area through to the pitted main-wall front surface to form a hole in the plate, or another spall formed to leave the hole in the main wall. A lack of control of the activity of the compression and relaxation waves has made the solid aluminum main walls particularly susceptible to failure. On the other hand, a detailed examination of the laminated main walls shows the no-failure results which can be achieved through control of the compression and relaxation waves by varying material properties throughout the plate thickness. Figures 19 and 20 are good examples of the operation of the laminated plate where each lamina has fulfilled its part in preventing laminated-plate failure. The first two metal laminae have stopped the debris of projectile and bumper. The polycarbonate lamina used as a shock-wave attenuator separating the outer aluminum laminae shows slight penetration at the center and large circular cracks at approximately 9 to 12 projectile radius. The last aluminum lamina used to trap the compression pulse and dissipate its energy through plastic deformation is shown in a final bulged condition, but still with no cracks through it. After an examination of these targets it can be noted that the laminated plates used here did not exhibit a separate spallation mode of failure as did the solid main walls (fig. 18). The solid main walls under these impact conditions have spallation failures before sustaining a penetration failure, and therefore a spallation-failure curve would be below the solid main-wall penetration curve in figure 14. Therefore, the superiority of the laminated main wall over the solid main wall is obvious from a spallation point of view also.
